## How to find and resolve Toner Sensor Errors: iColor 500, 600 and 700

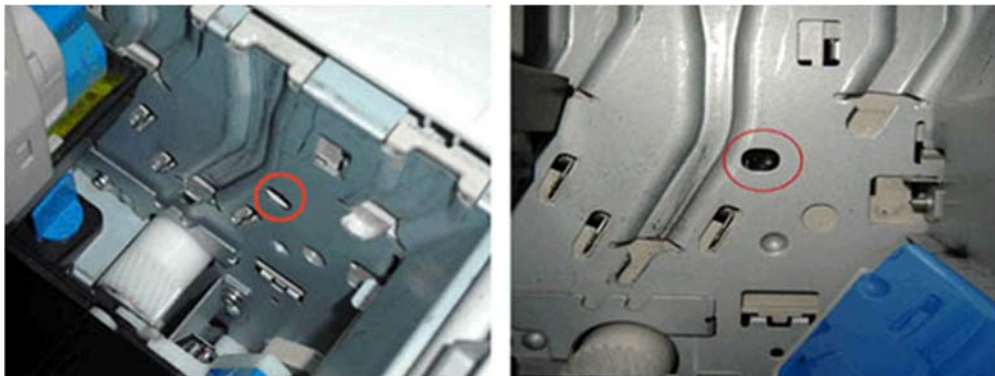
TS2: The Toner sensor on the machine can be found on the right hand side panel of the machine on the inside (see image below).

The sensor is enclosed in an oval shaped hole, this works in conjunction with the toner sensor located on the right hand side of the drum.

Toner sensor (view from above)

Toner sensor on the machine (side view)

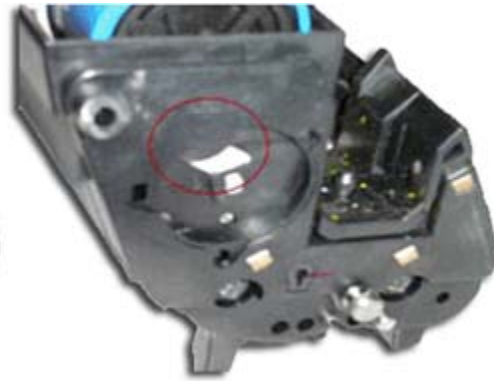
Incorrect Position

If it is incorrect it can sometimes result in the blanking disc not being pulled out of the way, this results in the sensor on the machine not picking up the sensor on the drum. Pushing the disc up will resolve the problem. The disc will not fall back down again, providing that the blue Toner Lever is pushed firmly to the back of the machine.

Check if the sensor lever on TS1 has been pushed up. Once you have cleaned the arm, check that the sensor lever has been pushed up (see Correct Position below).
